# Manhole Inspection Summary

Manhole # S35K\_\_047MH

Record Plat: **35K** Node: **047** Status: **New Manhole (Not in GIS)** Insp Date: **12/18/08 12:00 AM**

**Location** Address: **baltimore visitor center**

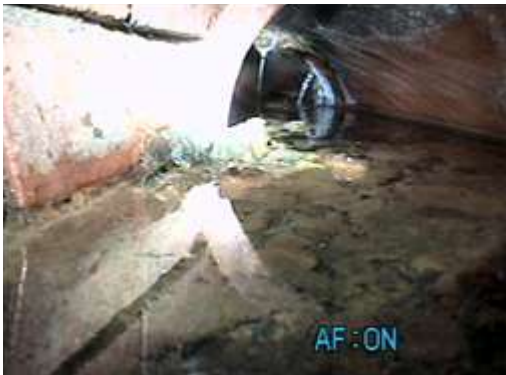
Defect 2

Infiltration: ☐ None ☐ Joint ☐ Cracks ☐ Mortar ☐ Roots ☒ **Wall**

barrel infiltration wall at seal of pipe 6  
OClock

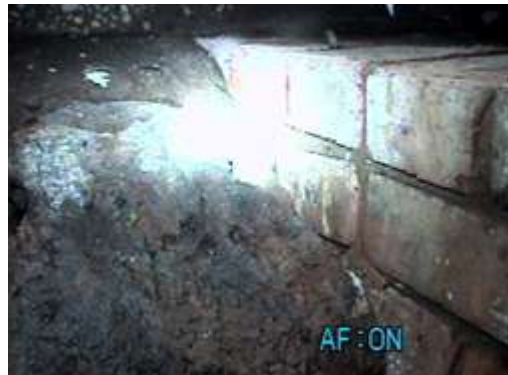
Defect 1

Condition: ☐ Sound ☐ Cracked ☐ Root Intrusion ☐ Deteriorated ☐ Leaks ☒ **Debris**

channel debris

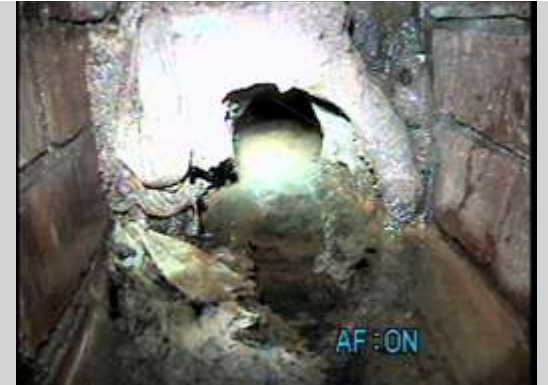
12 O'Clock Outflow

8 in. Circular Gravity Sewer  
Pipe Out @ 12 O'Clock

Infiltration: **None**

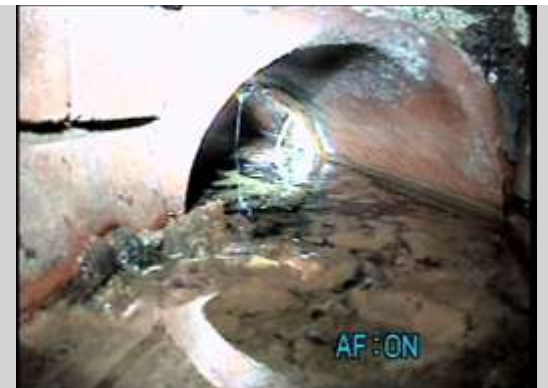
6 O'Clock Inflow

8 in. Circular Gravity Sewer  
Pipe In @ 6 O'Clock

Infiltration: **Runner**

Pipe Seal Cond: **Cracked**
